AGENDA

EMERGENCY MEETING WORCESTER COUNTY COMMISSIONERS

TO: Harold Higgins, County Administrator
Weston Young, Assistant County Administrator
FROM: Tom Perlozzo, Director of Recreation & Parks, Tourism, Economic Development
Kathryn Causey, Director Economic Development
DATE: September 16, 2020
RE: Riverboat Update and Request – TIME SENSITIVE

PURCHASE SURVEY #5549

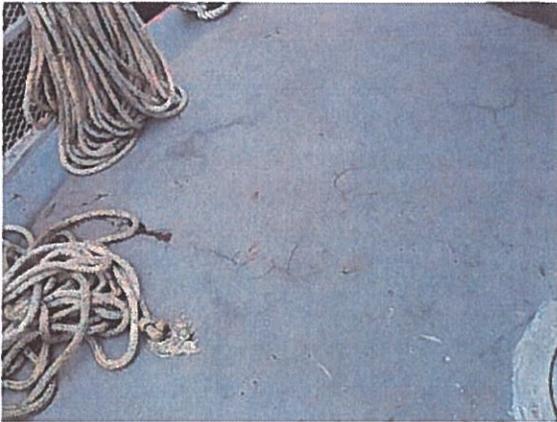
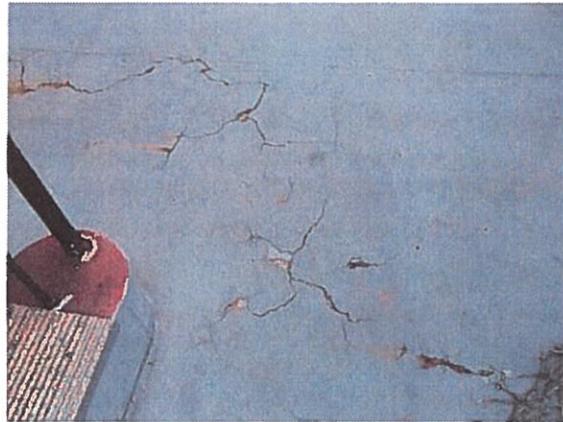
- a) The foredeck has paint failure with rusting under the paint. The random ultrasound readings where the paint had failed were .320" to .324". The deck is still structurally sound. The deck has some minor rusting with some crevice pitting.

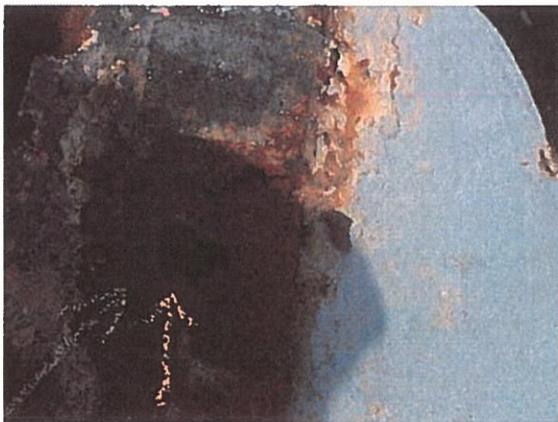
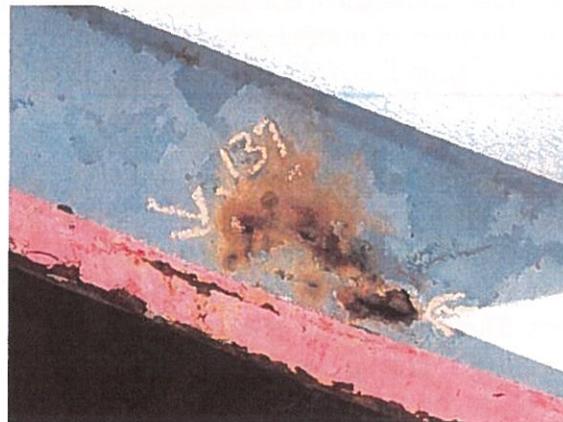
- b) The catwalks appears to be in fair order. However, on the starboard side, I have noted the following:
- 1) The deck is rusting through just under the railing for approximately 8" in length and 3" wide. The area is located 23" aft of the #1 compression post.
 - 2) At the #2 compression post under the railing, there is a 1" hole, which rusted through the deck. Also, a 1" hole is located 103" aft of the #2 compression post.

- 3) Across from the aft deck cleat to the rub rail, the deck is dented inward approximately 4".
- 4) Random ultrasound readings on the starboard catwalk ranged from .098" to .196".

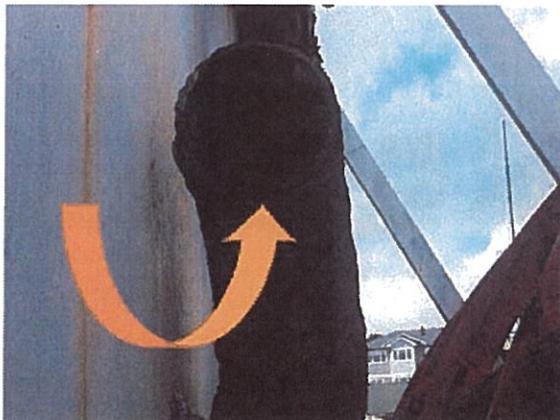
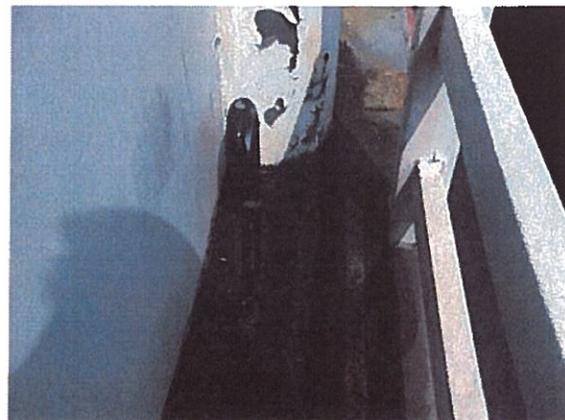
- 1) Overall, the catwalk is in satisfactory condition. Noted no areas that rusted through the deck.
 - 2) Where the cabin kicks out, water accumulates on the deck between the galley cabin and the main cabin.
- c) From what was accessible for inspection on the exterior, the cabin sides appear to be in satisfactory condition. However, at the forward bottom section of the cabin to the left of the access door to the engine compartment, the cabin plating has rusted through at the bottom. The backside of the cabin structure, the browl plate has heavy scaling. The exhaust pipe for the stove/oven has heavy scaling. I noted some minor rusting on the backside of the cabin.

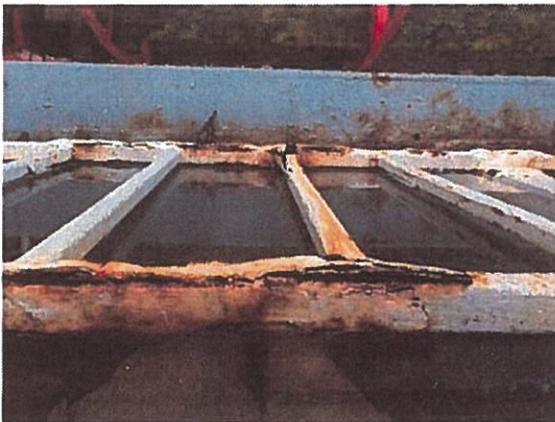
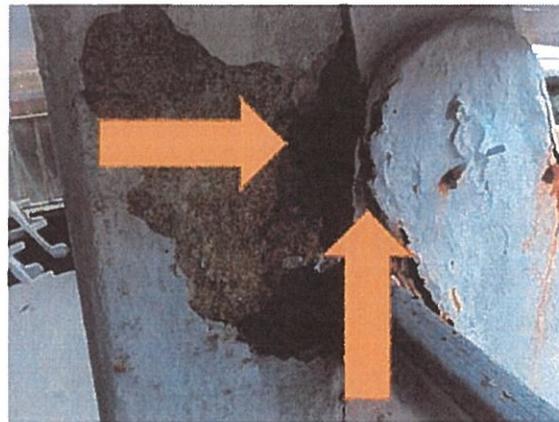
- e) The top of the spiral staircase is rusted. The rug was retaining water in this section. The steel plates that make up the opening for the staircase have heavy rusting.
- f) The center vertical support post at the upper deck aft section is scaling at the base. The two outboard support posts are also rusted at the base. There is heavy scaling on the bottom of the railing. Just above the railing, there is a knee welded to the post that supports the diagonal wheel framing support, which is rusted away.

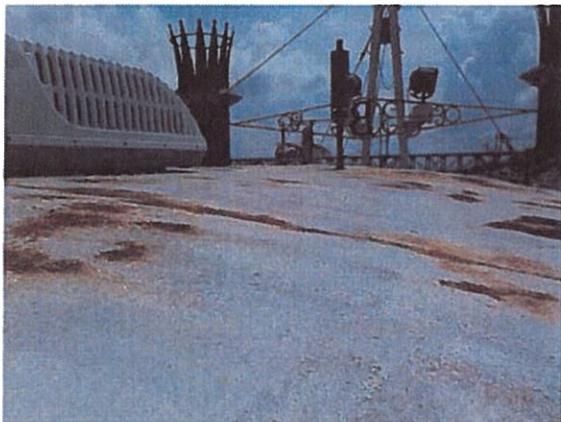
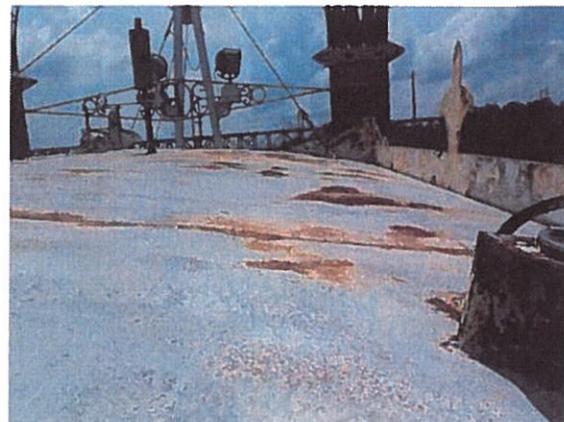
The fixed windows in the pilothouse are in good condition. However, the lower frame around the aft fixed windows is rusted.

The port side aft sliding window is cracked.

The top of the pilothouse has some rusting along with paint failure.

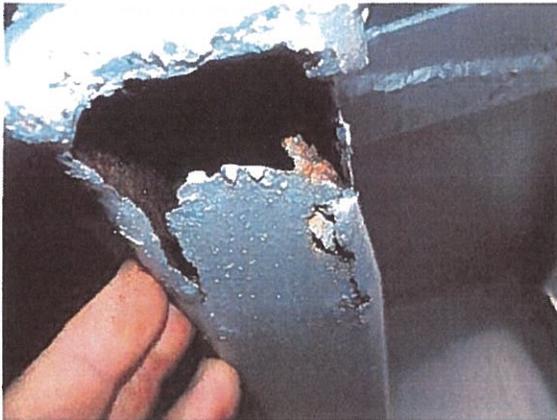
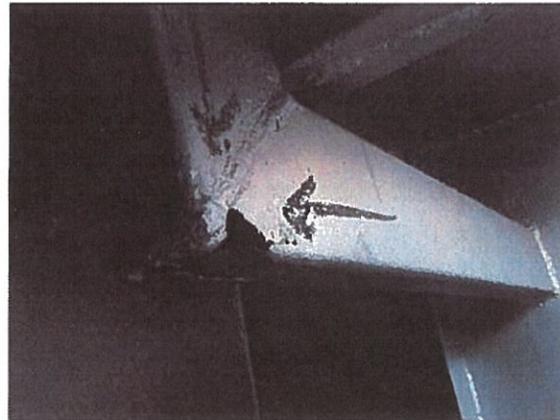
- m) In compartment #2, there is heavy scaling with paint failure between #1 and #2 stringers from the stem up for approximately 24". The #2 watertight bulkhead is in good condition. The hull sides are in good condition. There is some scaling on the stringers located under the manhole. The bottom readings in this area range from .272" to .308". The overhead channel is rusted through at the corner.

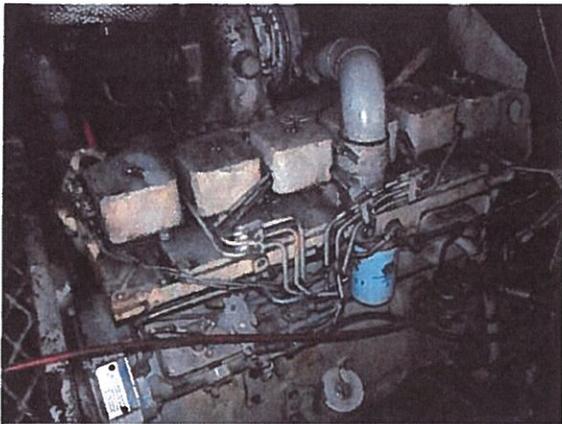
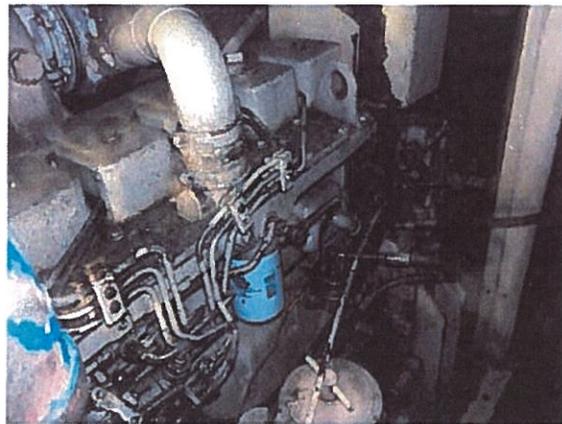
MACHINERY: the vessel is powered by twin Cummins, six cylinder, model 6BT 5.9, diesel engines. The port engine's serial number is 44224477. The starboard engine's serial number is 44245276. The engines are equipped with dry exhaust system and keel coolers. I have noted the following:

- a) The water circulation hoses are in fair condition.
- b) The hoses for the keel coolers on both sides are not properly supported. The hoses appear to be in fair condition.
- c) Boots are not installed to cover the starter cable terminal ends as per ABYC standard E-11.5.2.8.
- d) On the port and starboard engines, the alternator's positive terminal ends are not covered.
- e) The exhaust elbows are in fair condition.
- f) The motor mounts are solid and bolted to the engine bed.
- g) The linkage appears to be in good order.
- h) The starboard engine belt is in poor condition. The port engine belt was recently replaced.

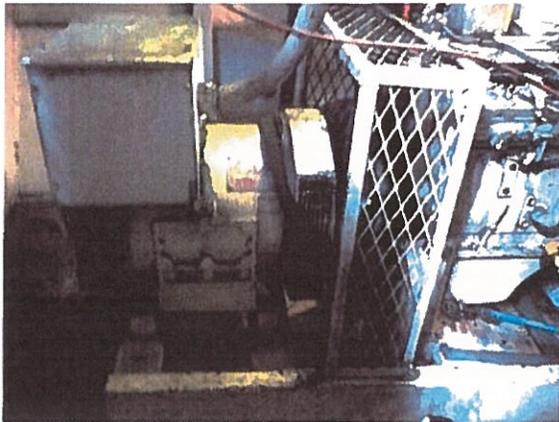
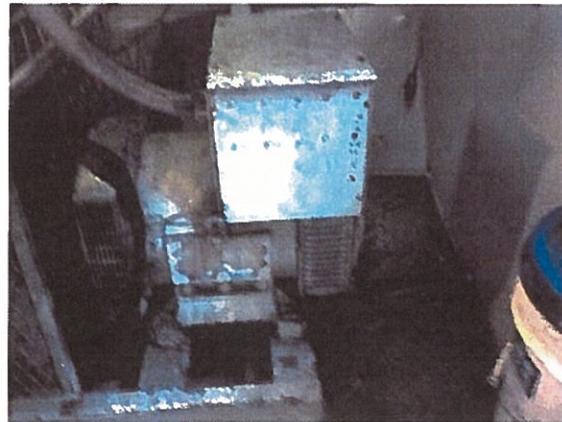
GENERATORS: two Stanford generators attached to the propulsion engines. The generators are well secured and did work. The voltage output of the port generator was 121.6 volts. The voltage output of the starboard generator was 122.5 volts. Each generator is 35 kW, triple phase. The serial number on the starboard generator is P216511. The id plate on the port generator is missing.

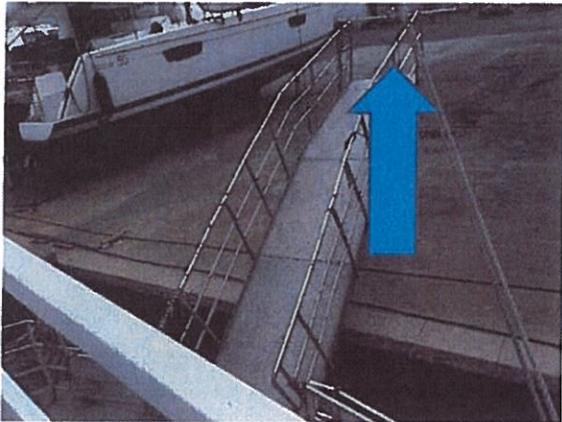
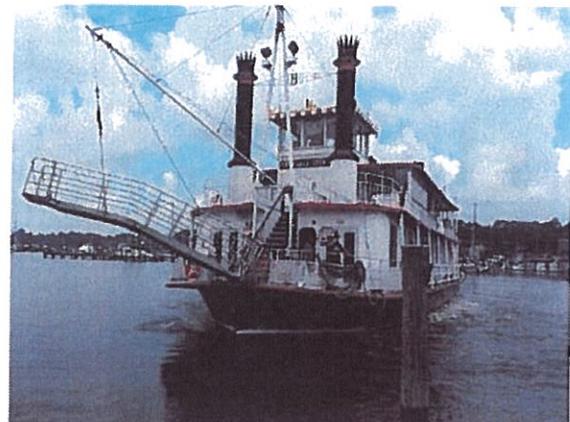
GANG PLANK: the vessel is equipped with an aluminum gang plank with a Strong Arm electric motor for the hoist. The cable is galvanized steel and appears to be in good order. The gang plank did work. I could not access the pivot connectors for proper inspection. However, what was accessible appeared to be in satisfactory condition. The forward end of the plank is broken.

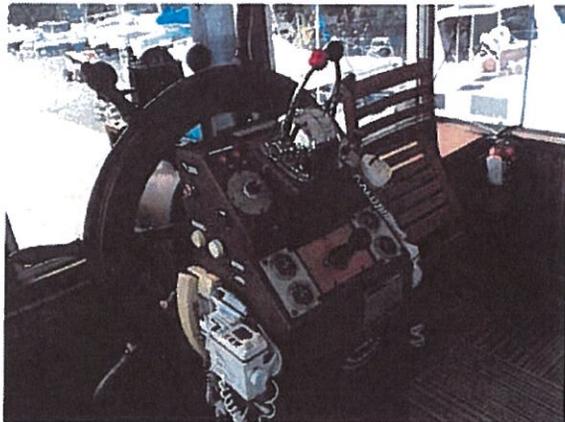
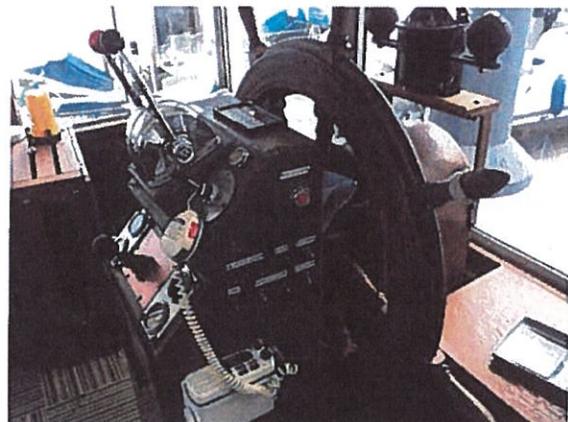
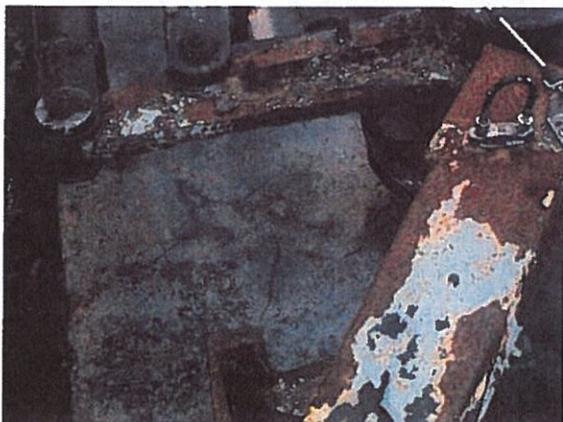
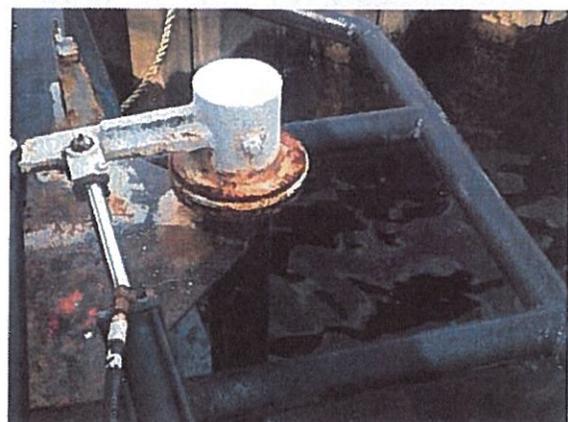
STEERING SYSTEM: hydraulic wheel steering with traditional wood spoke wheel and flanking rudders and steering rudders. The tie rod arm located in the aft rake is heavily rusted. The tie rod arm on the exterior has rusting. The hydraulic lines on the exterior hydraulic cylinders are in satisfactory condition.

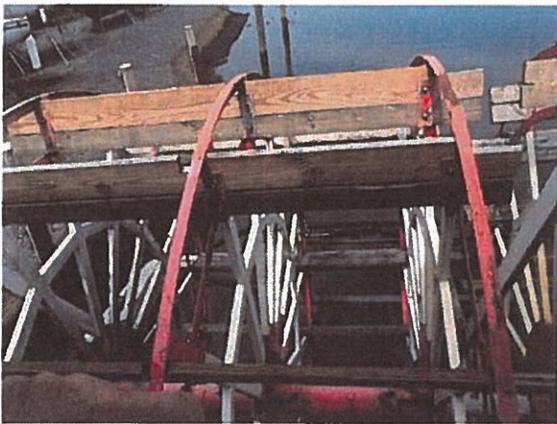
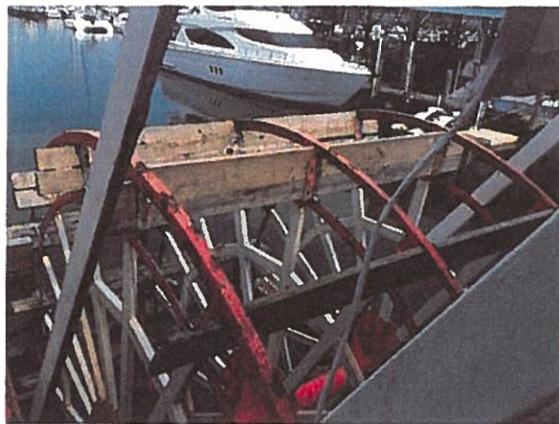
The paddle wheel armatures are rusted through at the ends. There is also heavy corrosion with scaling on the diagonal supports for the wheel armatures at the pinned ends. On the port side, the lower hydraulic fittings for the port paddle wheel have heavy corrosion. The knees for the paddle wheel hubs have heavy rusting and scaling.

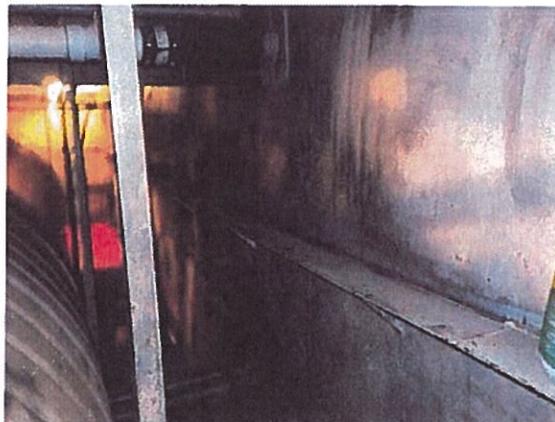
- a) The deck fill ports are painted yellow.
- b) The channel used for the hinged area for the covers of the fuel fill ports are rusted.
- c) The fuel pipes appear to be in good order from what was accessible for inspection.
- d) The Racor fuel filters appear to be in good order with no signs of leaks.
- e) The shut off valves worked.
- f) The fuel tank appears to be in good condition with no visual signs of leaks. However, I would recommend having the fuel tank pressure tested. The fuel tank does not have an information label as per ABYC standard H-33.16.3. I have no knowledge of the fuel tank, such as pressure test or manufacturing information.

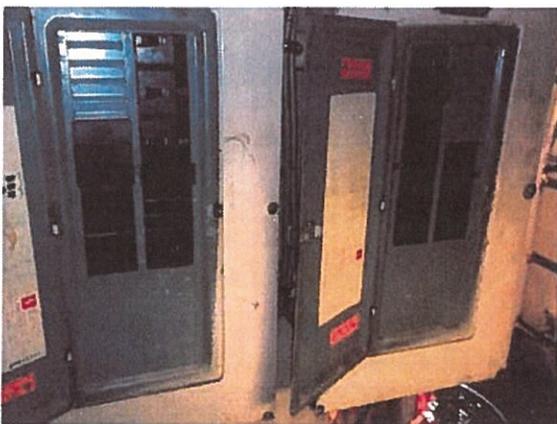
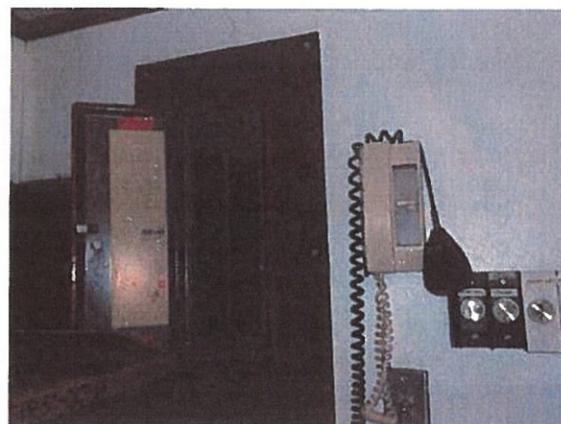
- b) I did detect the following wiring violations and/or safety hazards with the 12 volt system:
- 1) No main shut off switch for the starboard engine battery.
 - 2) Improper wire connections.

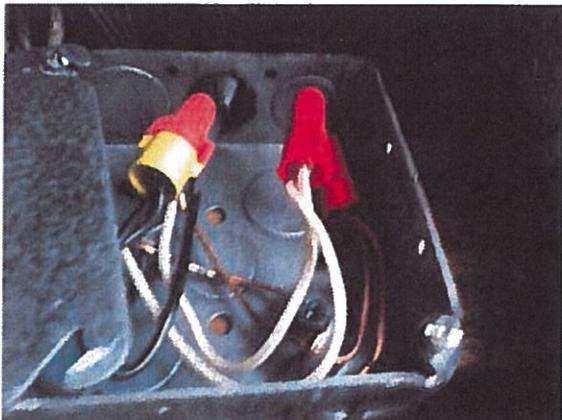
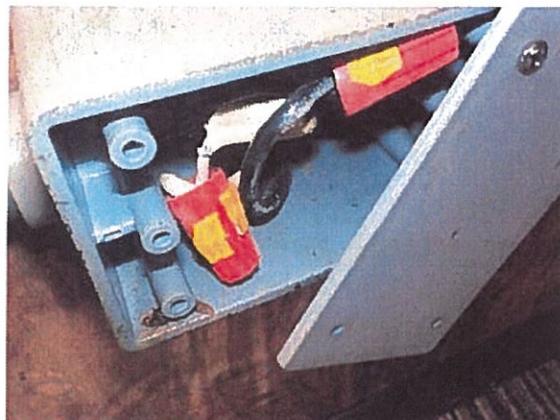
- c) Use of wire nuts for wire connections throughout the vessel.

- d) The electrical cables are not properly secured and open to chaffing.
- e) The light switch cover in the tankage compartment is improper.
- f) Power cord inlets for single phase are no longer in use.
- g) The shore power cord for the 208 volts is in poor condition. The cord is spliced and has tape rapped around it.
- h) The receptacles mounted on the port and starboard side in the aft rake by the vertical compression post have poor retention.

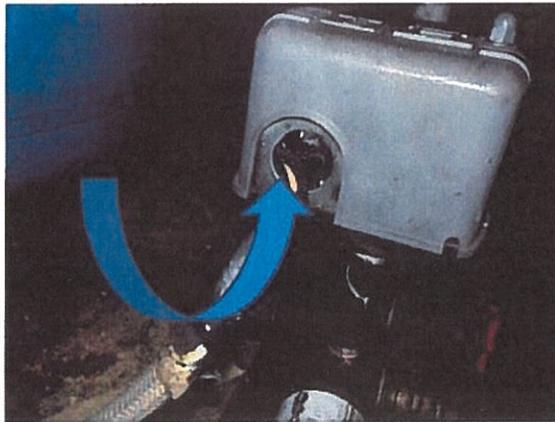
- i) Defective receptacle in the companionway to the engines.
- j) The forward light in the aft rake port compartment was out.
- k) There is solid core wire used throughout the vessel.
- l) There is no wire clamp for the pressure switch for the fresh water pump.

- m) The lower catwalk lights did not work.

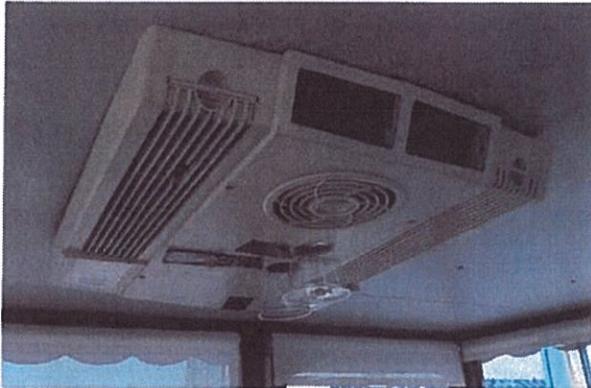
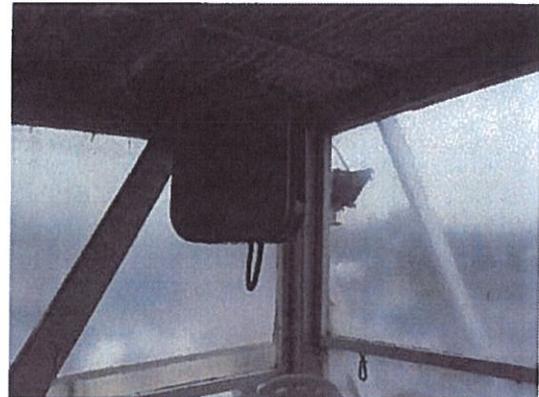
The vessel is also equipped with a Carrier camper style air conditioner in the ceiling in the pilot house, which does not work well. The air grid on the front section is missing.

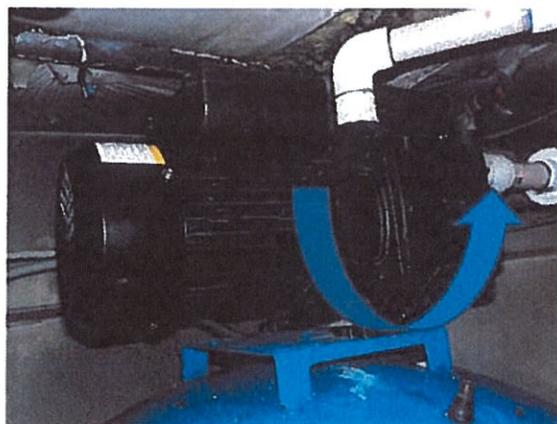
The 120 volt one horsepower shallow well jet pump appears to be in good condition. However, there is no wire clamp at the pressure switch. This pump supplies the fresh water. Also, there was a leak at the discharge end of the pump (arrow pointing at the leak.)

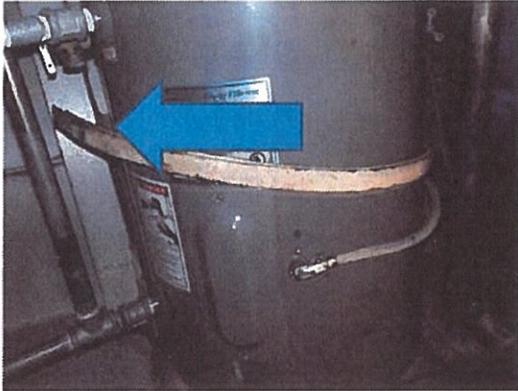
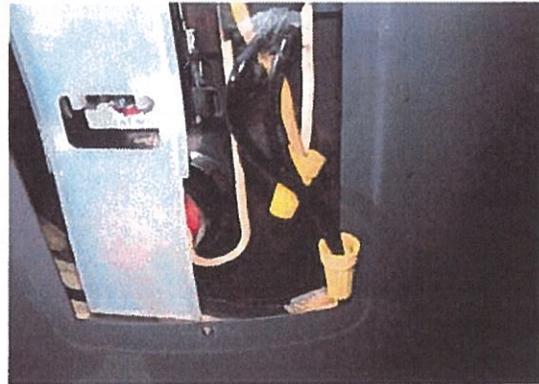
The vessel is equipped with a 15 gallon Vanguard hot water heater, serial number 0411335926. The hot water heater is not secured; the metal strap that holds the hot water heater is broken off. The hot water heater is wired with wire nuts and solid core wire. The hot water heater is not for marine application.

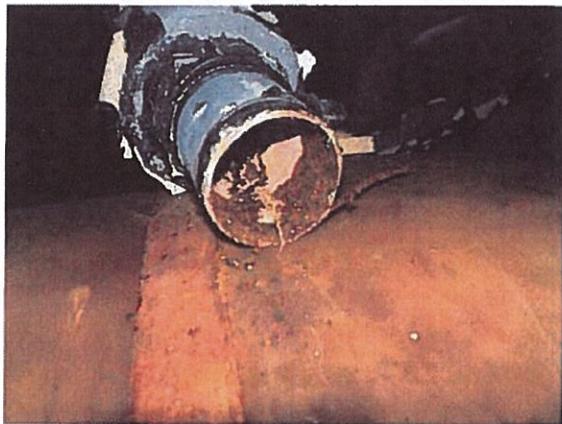
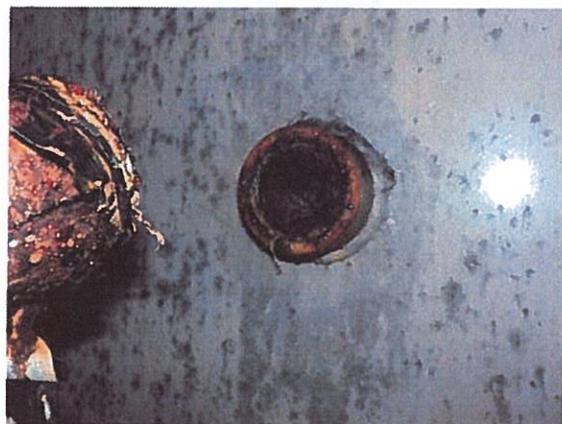
HEADS: the vessel is equipped with two heads located on either side of the galley and two heads located on the upper deck, with toilets, urinal, sinks, and three 500 gallon each holding tanks. The toilets are conventional household type. The operations of the toilets did work. The port aft holding tank vent is broken off.

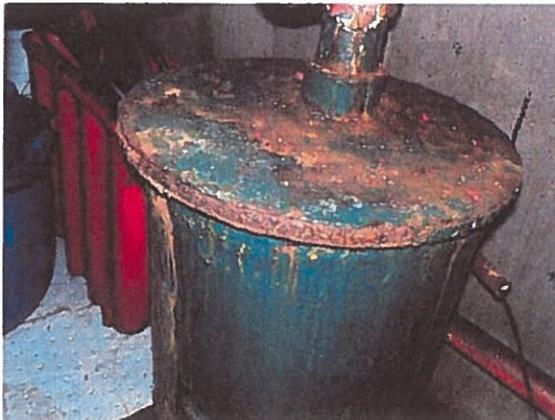
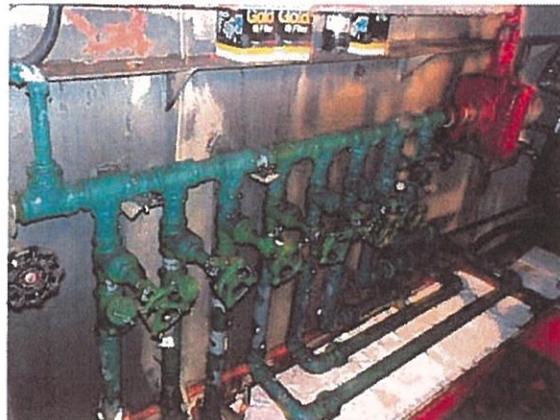
The vessel is equipped with one sea chest, which top of the unit is heavily scaled. Further evaluation will be required once the vessel is dry docked. All transfer gate valves in the machinery compartment worked. The bronze ball valve for the sea chest worked. This system feeds the fire hoses or discharge bilge water overboard. The gate valve in the forward compartment for the water intake for the fire pump needs to be reevaluated. The gate valve has an extension handle, which is rusted and corroded at the bottom.

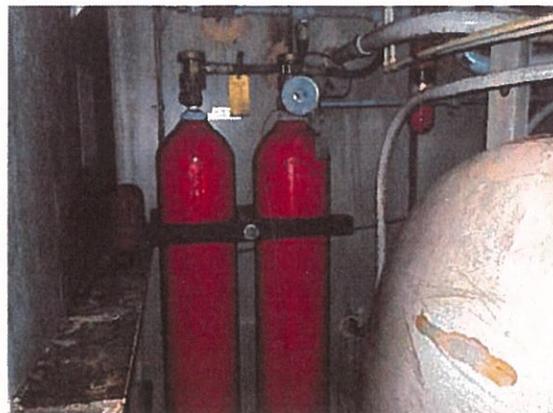
FIRE PROTECTION: the vessel is equipped with two electric pumps with fire hoses. There are carbon dioxide extinguishers and dry chemical fire extinguishers installed throughout the vessel. The fire extinguishers were being inspected at time of my inspection. The carbon dioxide extinguishers were not inspected at time of my inspection. An axe is mounted in the stairway to the pilot house. There are no smoke or carbon monoxide detectors installed.

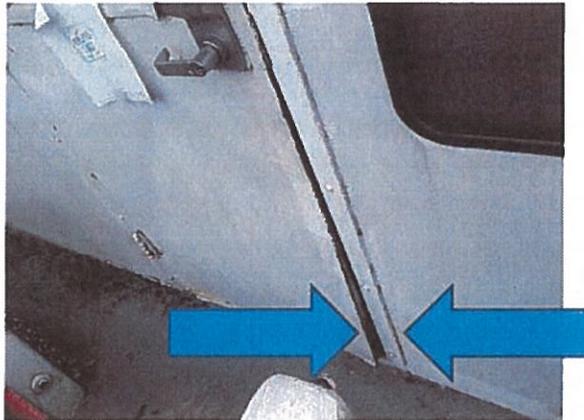
- c) The main salon windows are in good condition with no signs of cracks or broken windows.
- d) The fixed windows in the heads, main salon, and pilot house are in good condition. However, in the pilot house, the base of the port side window is rusted out.
- e) The sliding window in the pilothouse port side is cracked at the bottom.
- f) The engine hatch door is in good condition. The doggs are in satisfactory condition. However, this is the only means of escape. As per 46 CFR 92.10-5(a), there needs to be at least two means of escape.
- g) The manhole covers for compartments #1 and #2 appear to be leaking.
- h) The starboard side cabin door is bent at the bottom.

- i) The latch on the port side tankage compartment escape hatch is broken.

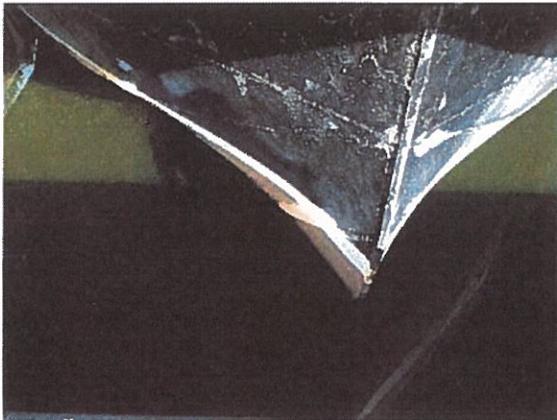
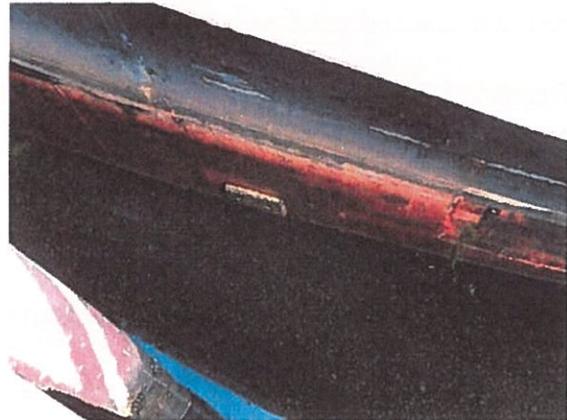
The haul out was scheduled for August 12, 2020. However, the weight of the boat exceeded the travel lift capacity. The boat was lifted out of the water for approximately 2'. I was able to see the sacrificial anodes attached to both sides of the hull, which were in satisfactory condition. The sides of the hull were covered with marine growth, so inspection was very limited. From what was accessible for inspection, I could see that there was no damage to the hull sides and bow.
