AGENDA

EMERGENCY MEETING WORCESTER COUNTY COMMISSIONERS

TO: Harold Higgins, County Administrator
Weston Young, Assistant County Administrator
FROM: Tom Perlozzo, Director of Recreation & Parks, Tourism, Economic Development
Kathryn Causey, Director Economic Development
DATE: September 16, 2020
RE: Riverboat Update and Request – TIME SENSITIVE

PURCHASE SURVEY #5549

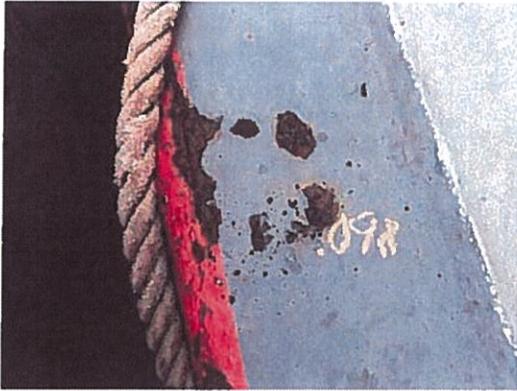
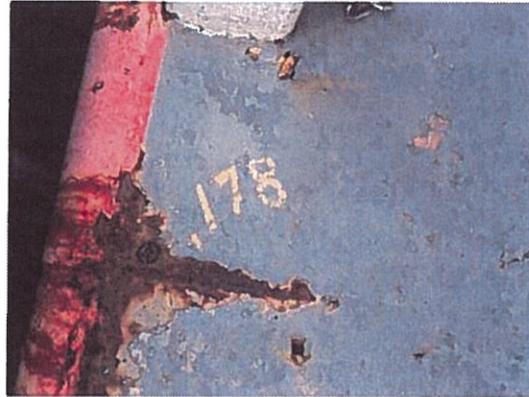
- b) The catwalks appears to be in fair order. However, on the starboard side, I have noted the following:
- 1) The deck is rusting through just under the railing for approximately 8" in length and 3" wide. The area is located 23" aft of the #1 compression post.
 - 2) At the #2 compression post under the railing, there is a 1" hole, which rusted through the deck. Also, a 1" hole is located 103" aft of the #2 compression post.

- 3) Across from the aft deck cleat to the rub rail, the deck is dented inward approximately 4".
- 4) Random ultrasound readings on the starboard catwalk ranged from .098" to .196".

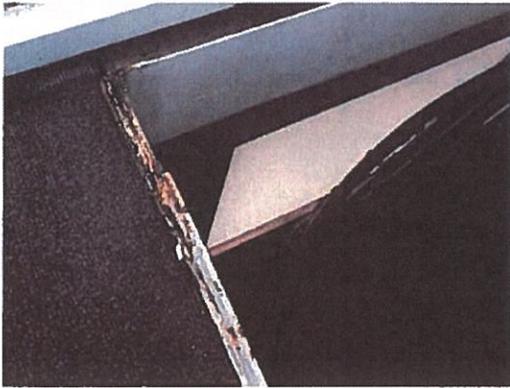
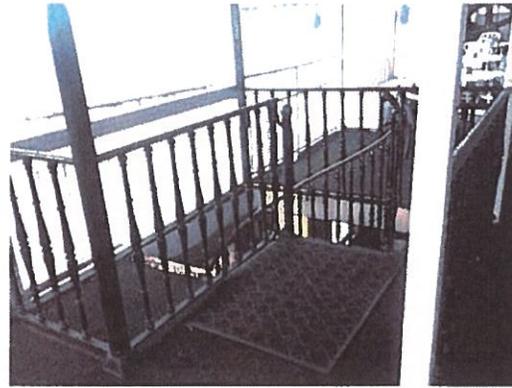
- 1) Overall, the catwalk is in satisfactory condition. Noted no areas that rusted through the deck.
 - 2) Where the cabin kicks out, water accumulates on the deck between the galley cabin and the main cabin.
- c) From what was accessible for inspection on the exterior, the cabin sides appear to be in satisfactory condition. However, at the forward bottom section of the cabin to the left of the access door to the engine compartment, the cabin plating has rusted through at the bottom. The backside of the cabin structure, the browl plate has heavy scaling. The exhaust pipe for the stove/oven has heavy scaling. I noted some minor rusting on the backside of the cabin.

- d) The upper deck is carpeted with indoor/outdoor carpet. The deck appears to be solid and in satisfactory condition. The corrugated overhead panels are in satisfactory condition. I did note some leaks. The plywood panel on the port side by the doorway is soft at the bottom. The panels by both doorways are not secured at the bottom.

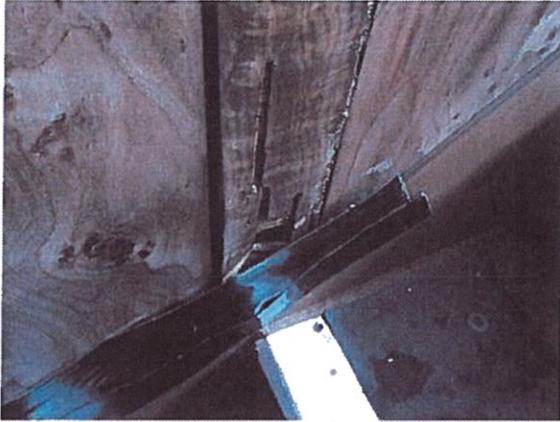
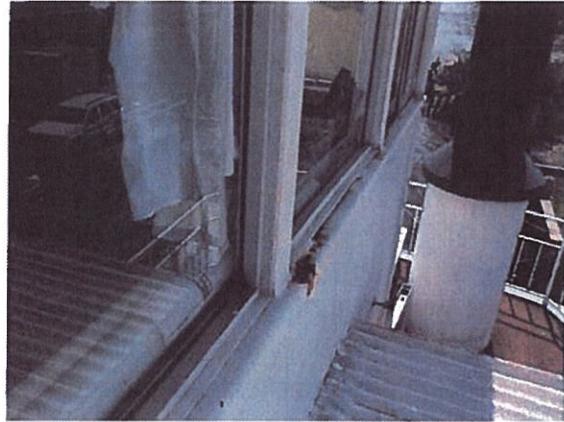
The fixed windows in the pilothouse are in good condition. However, the lower frame around the aft fixed windows is rusted.

The port side aft sliding window is cracked.

The top of the pilothouse has some rusting along with paint failure.

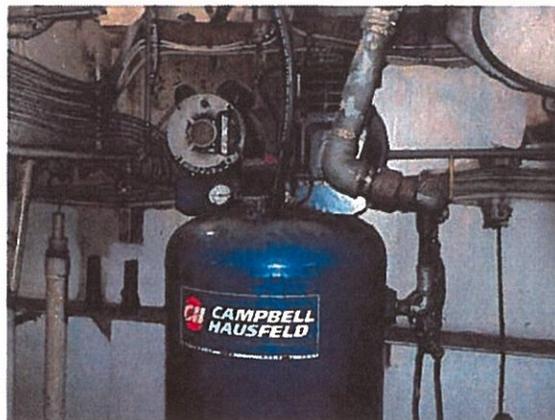
AIR COMPRESSOR: Campbell Hausfeld air compressor, which appears to have been properly installed. The compressor did work.

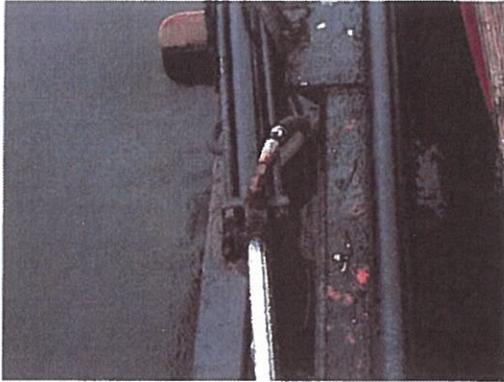
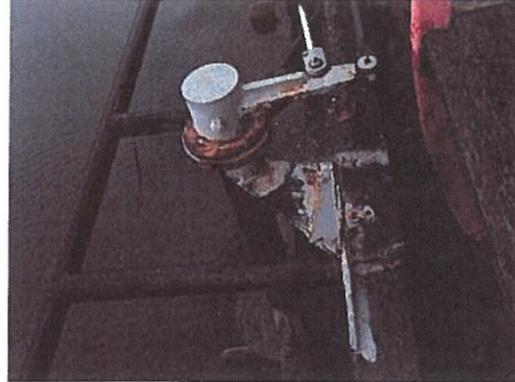
PADDLE WHEELS: the vessel is equipped with two paddle wheels. The paddles are made up of 2" x 6" x 10' and 2" x 8" x 10' treated lumber bolted onto steel frames. The paddles appeared to be in good order with no defects noted at the time of my inspection.

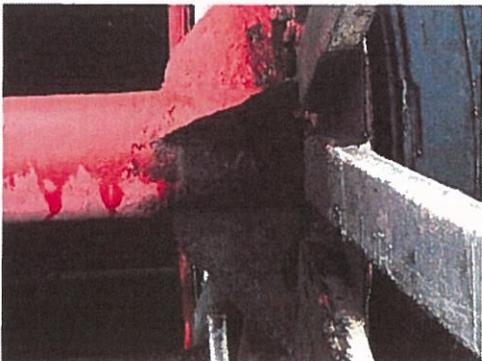
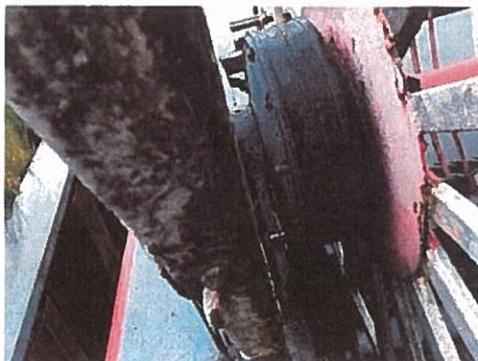
The paddle wheel armatures are rusted through at the ends. There is also heavy corrosion with scaling on the diagonal supports for the wheel armatures at the pinned ends. On the port side, the lower hydraulic fittings for the port paddle wheel have heavy corrosion. The knees for the paddle wheel hubs have heavy rusting and scaling.

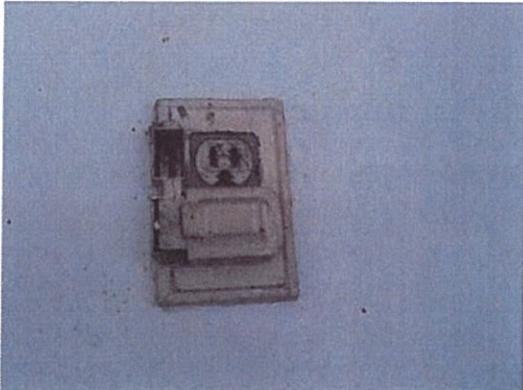
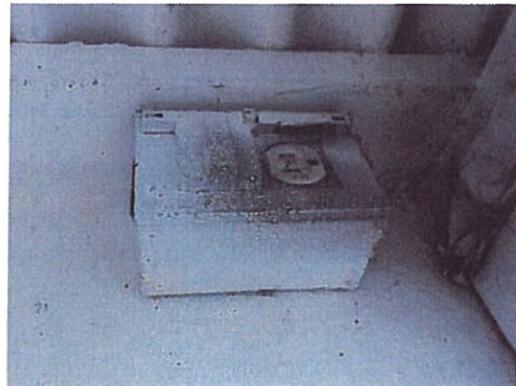
- b) There is a faulty breaker in the closet located under the pilot hose on the port side. It is on the right side of the panel and second breaker down. The two pictures below are receptacles that do not work.

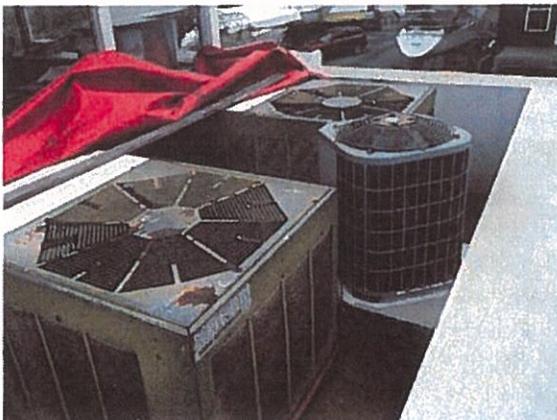
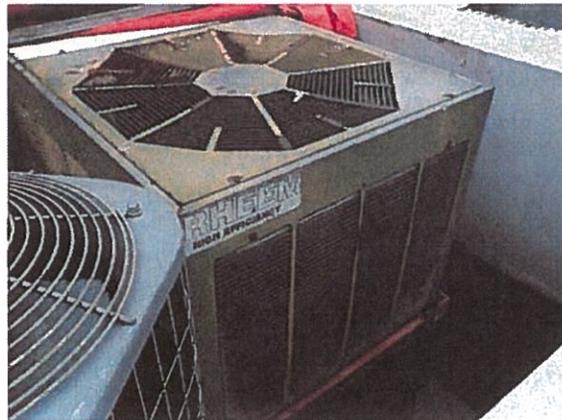
AIR CONDITIONERS: the vessel is equipped with 3 commercial air conditioner units, mounted on the upper deck. The air conditioners did work.

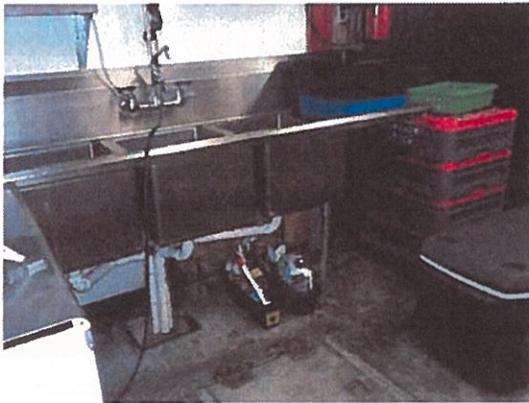
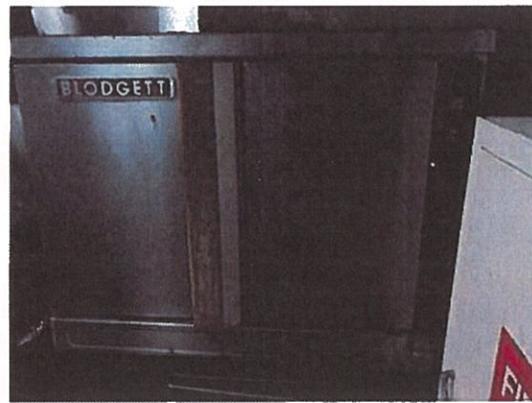
- a) Commercial stainless steel sinks with a faucet for hot and cold pressurized water. The drain line is in good condition.
- b) Blodgett commercial oven, which did work. The oven is not properly secured. The exterior stove pipe is corroded.
- c) There is a small refrigeration unit that did work. The larger refrigeration unit does not go with the boat and is leased.

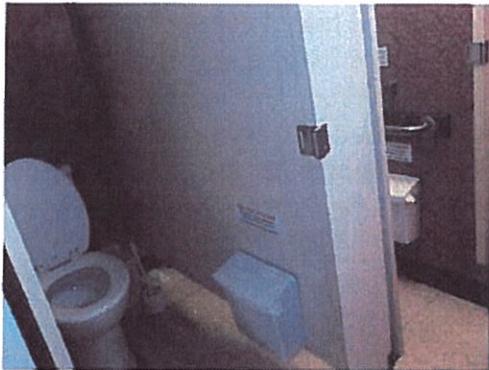
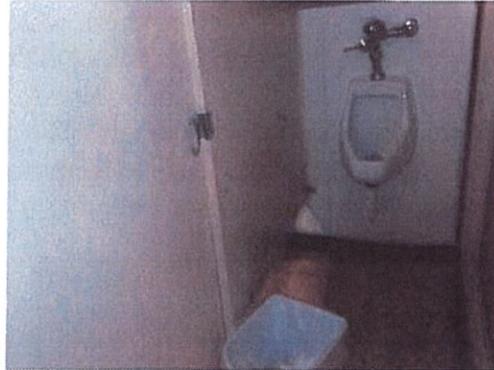
HEADS: the vessel is equipped with two heads located on either side of the galley and two heads located on the upper deck, with toilets, urinal, sinks, and three 500 gallon each holding tanks. The toilets are conventional household type. The operations of the toilets did work. The port aft holding tank vent is broken off.

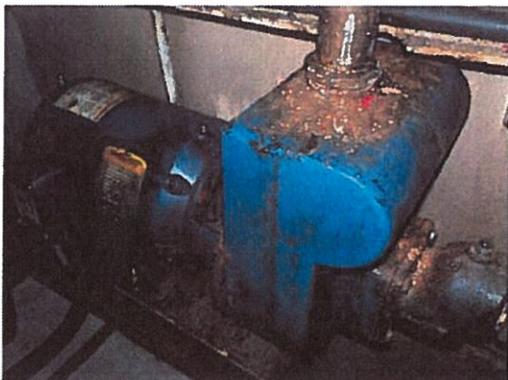
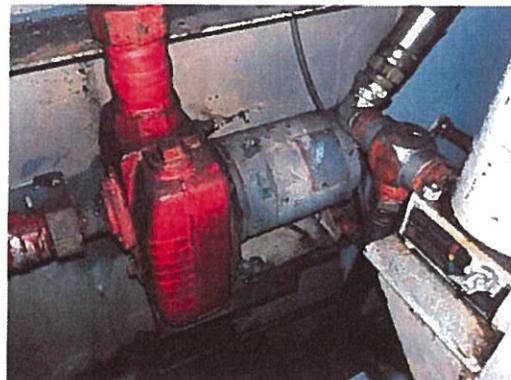
BILGE PUMPS: the vessel is equipped with two electric 208 volt pumps (one Balder and one Centry), which has piping to each compartment with strainers on the end of each intake pipe. The pumps were not tested. The USCG is tested the bilge pumps on August 17, 2020, as per owner.

There are high water float switch alarms, which are routed to the pilot house. The float switch in the engine compartment is not secured. The float switch in the aft rake is secured and did work.

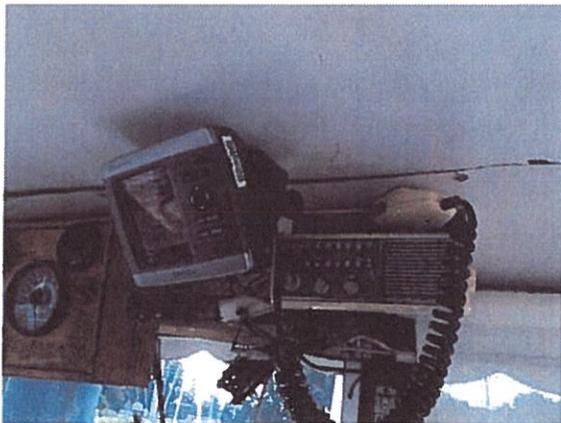
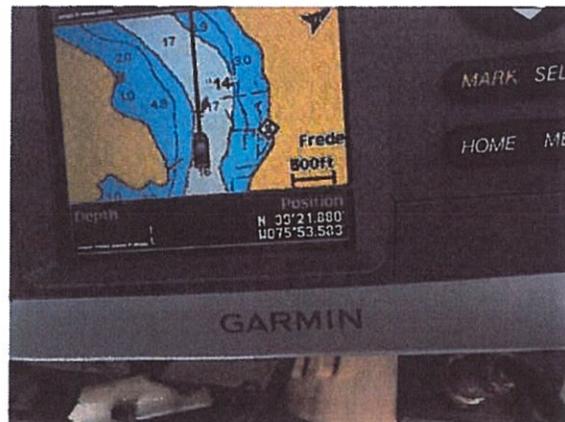
- a) The two Standard Horizon VHF's did work.
- b) The Datamarine Sandpiper depth finder did work.
- c) The Garmin GPSmap 441S GPS/knot meter worked giving a reading of 39°21.862 / 075°54.005.
- d) The Danforth Constellation steel boat compass is in fair condition. The light shade on the compass is broken. The compass light did work.
- e) The PA system appears to be in good order.

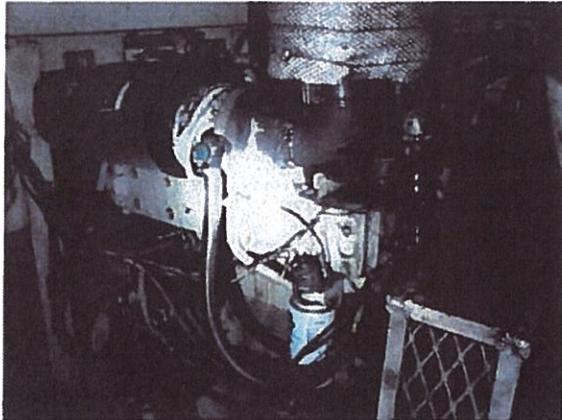
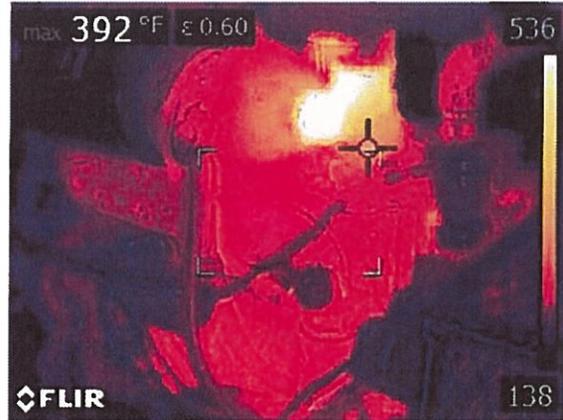
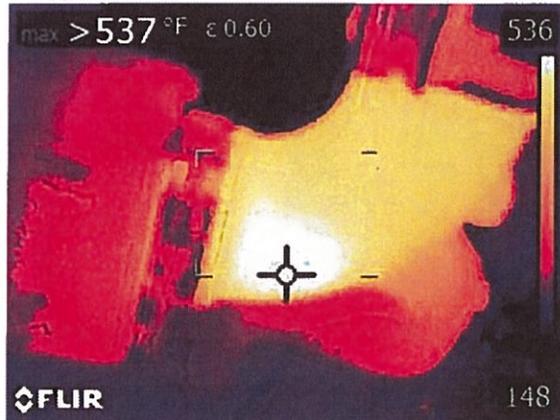
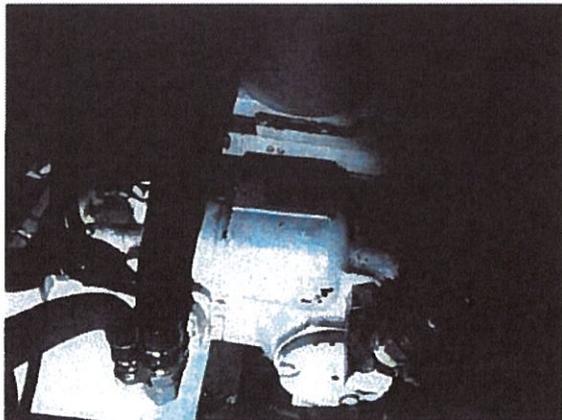
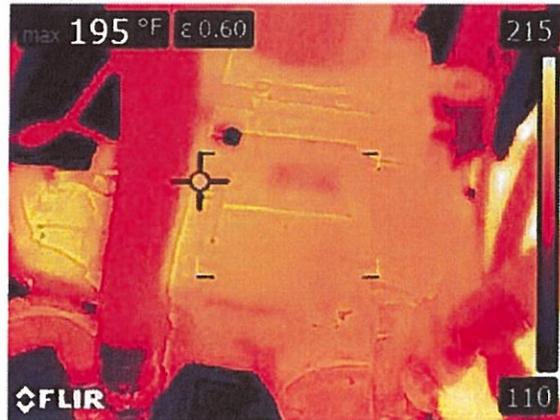
PORT ENGINE

THERMAL IMAGING (cont.)

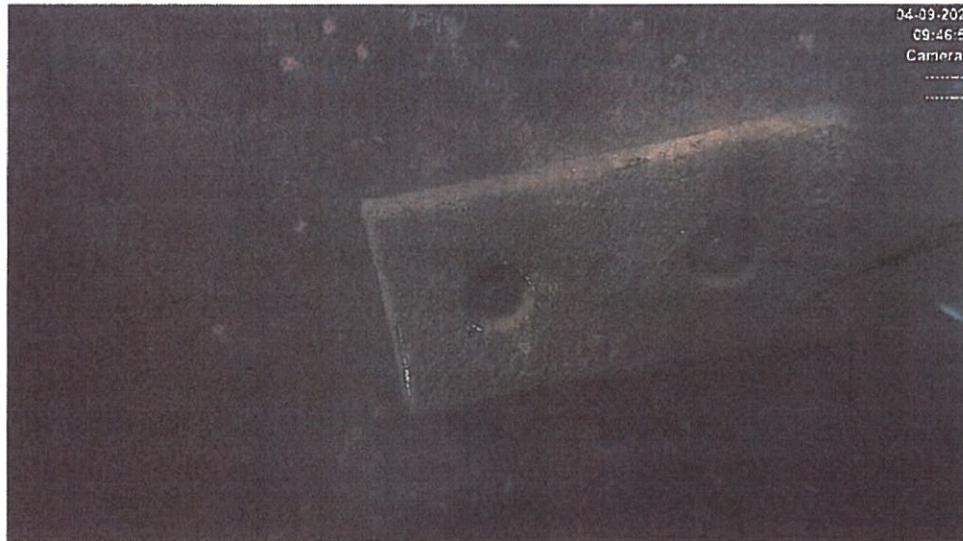
(STILL OF SEA CHEST INTAKE)

- d) Remove all standing water from the hull interior.
- e) Repair the leaking line for the fresh water pump.
- f) Repair or replace the rpm gauge.
- g) Repair the heavy rusting of the sea chest.

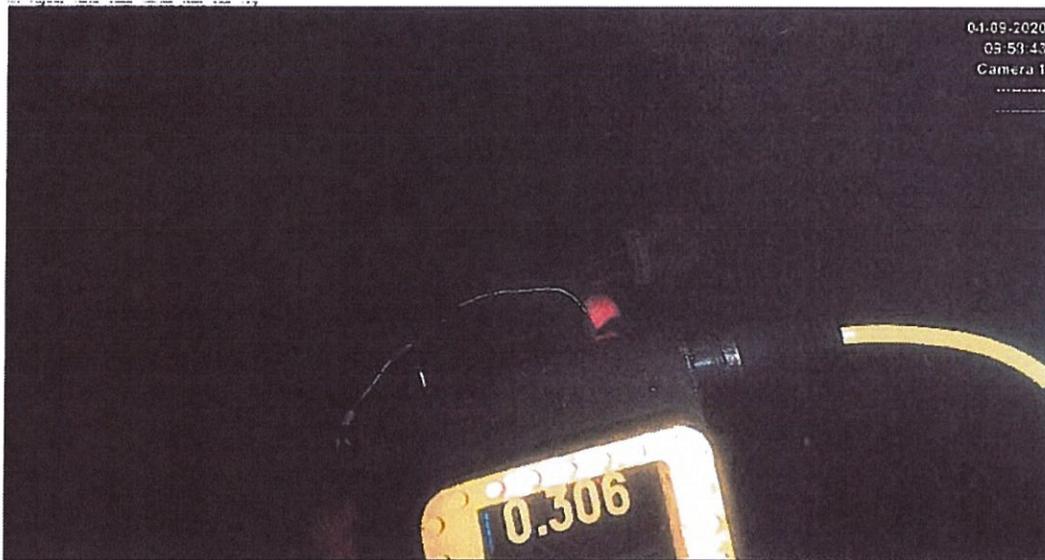
(STILL OF A TYPICAL ANODE)

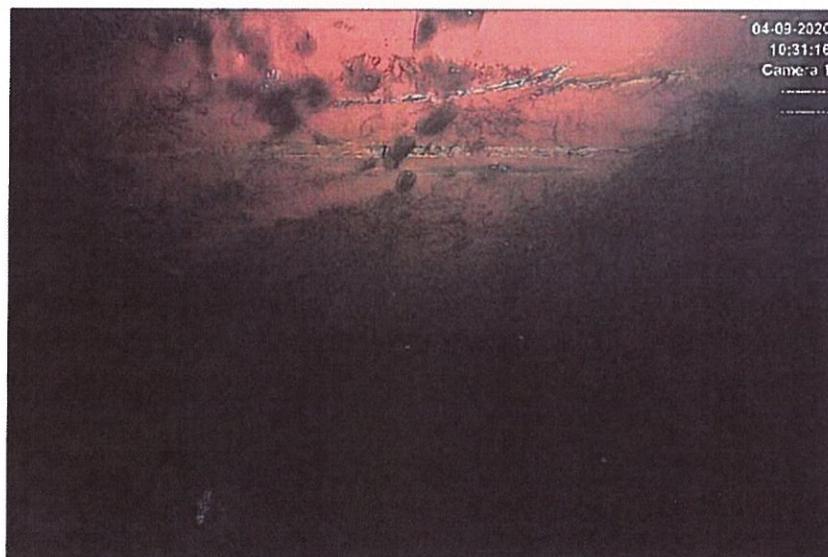
(STILL OF AN NDT READING)
